**Flood Control Project Maintenance  
Levee Inspections**  
**LMA District Cover Sheet**  
**Spring 2019 Levee Inspection Results**

**Reclamation District No. 2031 Elliot**

**Levee Inspection Report By Mile - Spring 2019**

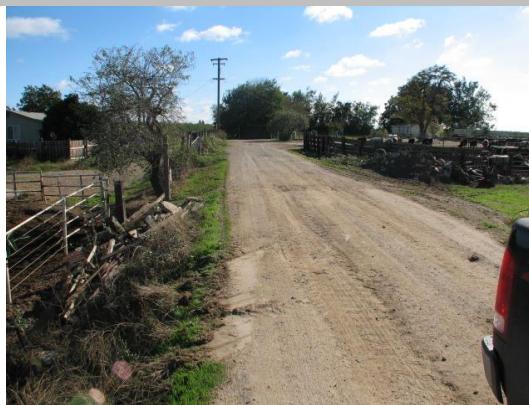
Photo 2 of 2 : SP\_2019\_RD2031\_307\_963\_20190313\_00023.jpg

Fall 2009 photo looking upstream at beginning of unit 1. Waterside to the left.

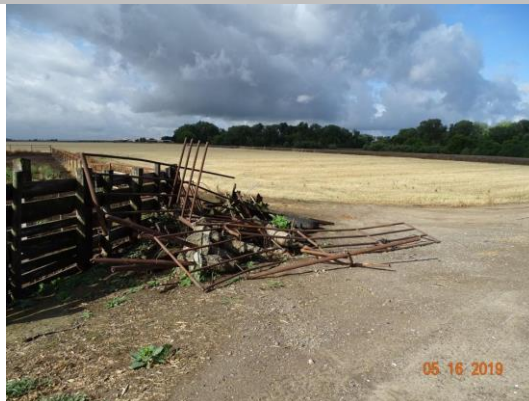
Photo 1 of 1 : SP\_2019\_RD2031\_307\_29\_20190520\_00084.jpg

LM Start	0.01	Rating **	U	Issue No.	29
LM End	0.01	Issue Type +	En	Location *	LS
Category	Earthen Levee			GPS Latitude/Longitude	
				Start	End
Item	Encroachments			37.709998 °	37.709998 °
				-121.155514 °	-121.155514 °
DWR ID	DWR_RD2031_01_s_2019_29				
Comment Code					
DE : Debris					
Inspector Comment					
Debris pile, old fence post, metal fence gates, concrete rubble, and old fence material are located on the landside shoulder.

View of debris on landside shoulder of old fence posts, metal gates, fence material and concrete rubble. (Spring 2019)

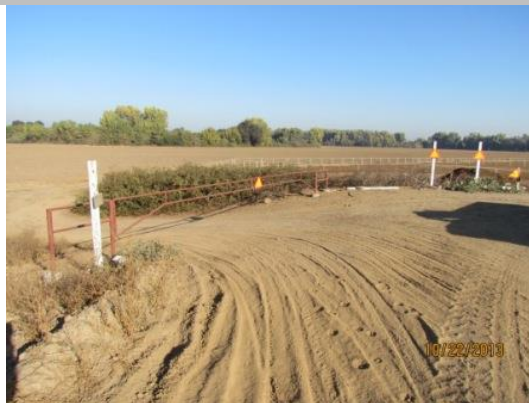
Photo 1 of 1 : SP\_2019\_RD2031\_307\_50\_20190313\_00014.jpg

LM Start	0.06	Rating **	M	Issue No.	50
LM End	0.06	Issue Type +	En	Location *	WS
Category	Earthen Levee			GPS Latitude/Longitude	
				Start	End
Item	Encroachments			37.709950 °	37.709950 °
				-121.156540 °	-121.156540 °
DWR ID	DWR_RD2031_01_f_2013_50				
Comment Code					
FE : Fence					
Inspector Comment					
There is a metal cross gates at the waterside levee hinge.

View of the gate at the waterside levee hinge.

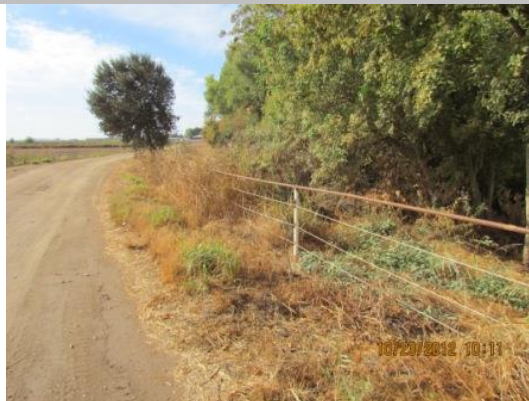
Photo 3 of 3 : SP\_2019\_RD2031\_307\_7\_20190313\_00004.jpg

View of fence on waterside slope facing downstream.

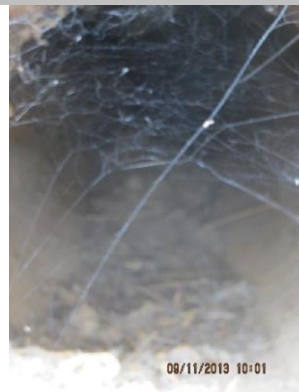
Photo 2 of 3 : UCIP\_SP\_2019\_20049\_33955.jpg

LM Start	0.80	Rating **	M	Issue No.	977 (cont)	
LM End	0.80	Issue Type +	En	Location *		
Category	Supplemental			GPS Latitude/Longitude		
				Start	End	
Item	DWR UCIP Field Study			37.700853 °	37.700853 °	
				-121.162349 °	-121.162349 °	
DWR ID	20443					
Comment Code						
Inspector Comment						
FS_ID:20049						
DS_ID:20443						
EP_NO: N/A						
Repair Type: Non-Urgent						
Crossing Status: Found						
UCIP Comments: Pipe appears abandoned as WS slope is covered with soil. If abandoned, it should be done so properly.						
FIELD_STRUCT_DESC: 24-inch steel irrigation pipe through the levee, 2 feet below the crown. Concrete headwalls on both sides of the levee crown. [Additional Reference(s): DWR Levee Log, 2005. USACE San Joaquin O&M Manual 4, June 1968, (HLM 0.81)].						
FS Date: 9/11/2013

Pipe not filled with concrete.

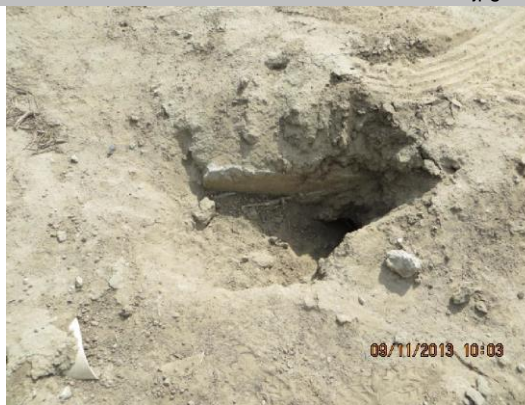
Photo 3 of 3 : UCIP\_SP\_2019\_20049\_33954.jpg

Concrete headwall on WS shoulder buried.

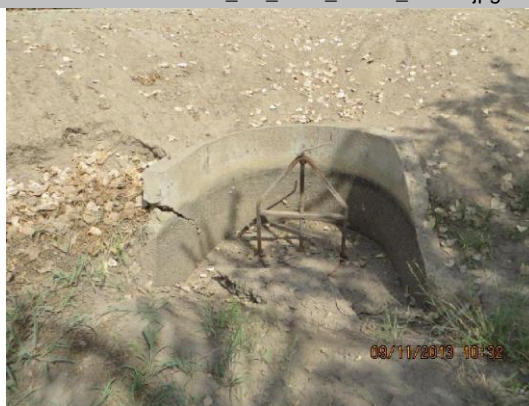
Photo 2 of 3 : UCIP\_SP\_2019\_47158\_74941.jpg

Front view of concrete structure located on landward toe.

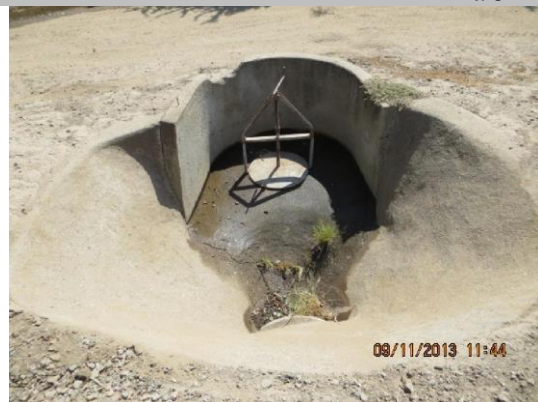
Photo 1 of 3 : UCIP\_SP\_2019\_20088\_34030.jpg

LM Start	1.55	Rating **	A/W	Issue No.	980
LM End	1.55	Issue Type +	Ma	Location *	
Category	Supplemental			GPS Latitude/Longitude	
				Start	End
Item	DWR UCIP LMA Responsibility			37.698921 °	37.698921 °
				-121.174144 °	-121.174144 °
DWR ID	20446				
Comment Code					
Inspector Comment					
FS_ID:20088					
DS_ID:20446					
EP_NO: N/A					
Repair Type: No Action Needed					
Crossing Status: Found					
UCIP Comments:					
FIELD_STRUCT_DESC: 24-inch corrugated metal drainage pipe through the levee, 3.5 feet below the crown. Concrete headwalls on both ends. Flap gate on the waterside (WS) end. Installed by USACE in 1966. [Additional Reference(s): DWR Levee Log, 2005. USACE San Joaquin O&M Manual 4, June 1968, (HLM 1.56)].					
FS Date: 9/11/2013

Bowl shaped concrete inlet on LS slope.

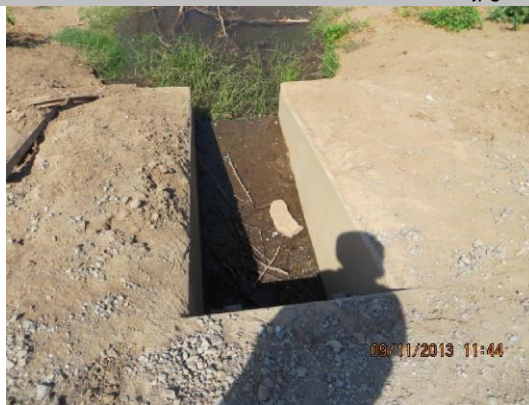
Photo 3 of 3 : UCIP\_SP\_2019\_20088\_34028.jpg

Concrete U-shaped headwall on WS slope.

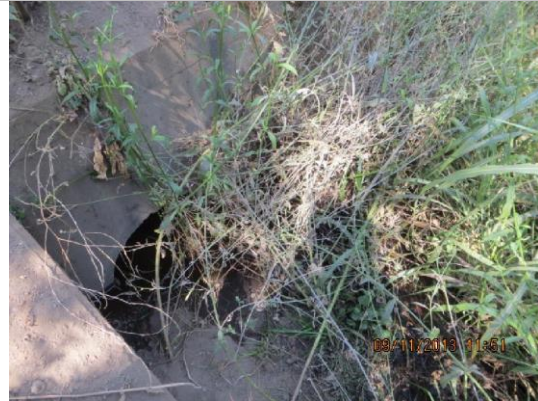
Photo 3 of 3 : UCIP\_SP\_2019\_41354\_34032.jpg

LM Start	1.78	Rating **	M	Issue No.	981 (cont)	
LM End	1.78	Issue Type +	Ma	Location *		
Category	Supplemental			GPS Latitude/Longitude		
				Start	End	
Item	DWR UCIP LMA Responsibility			37.696958 °	37.696958 °	
				-121.177464 °	-121.177464 °	
DWR ID	20470					
Comment Code						
Inspector Comment						
FS_ID:41354 DS_ID:20470 EP_NO: N/A Repair Type: Non-Urgent Crossing Status: Found UCIP Comments: Silt buildup at inlet and outlet. FIELD_STRUCT_DESC: 1 of 2: 24-inch corrugated metal drainage pipe through the levee, 9.5 feet below the crown. Concrete U-shaped headwalls on both ends. Flap gate on the waterside (WS) end. Installed by USACE in 1966. [Additional Reference(s): DWR Levee Log, 2005. USACE San Joaquin O&M Manual 4, June 1968, (HLM 1.80)]. FS Date: 9/11/2013

Concrete headwall at LS toe.

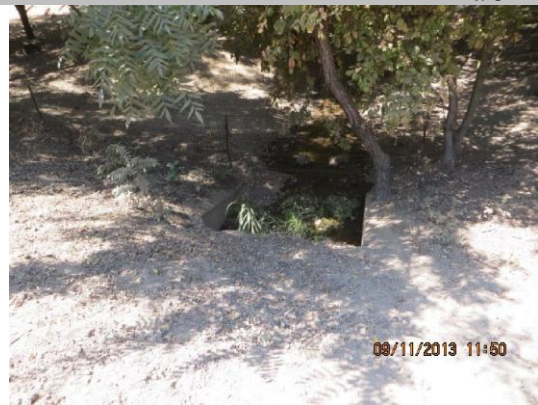
Photo 1 of 3 : UCIP\_SP\_2019\_20092\_34041.jpg

LM Start	1.78	Rating **	M	Issue No.	982	
LM End	1.78	Issue Type +	Ma	Location *		
Category	Supplemental			GPS Latitude/Longitude		
				Start	End	
Item	DWR UCIP LMA Responsibility			37.696943 °	37.696943 °	
				-121.177470 °	-121.177470 °	
DWR ID	20447					
Comment Code						
Inspector Comment						
FS_ID:20092						
DS_ID:20447						
EP_NO: N/A						
Repair Type: Non-Urgent						
Crossing Status: Found						
UCIP Comments: Silt buildup at inlet and outlet.						
FIELD_STRUCT_DESC: 2 of 2: 24-inch corrugated metal drainage pipe						
through the levee, 9.5 feet below the crown. Concrete U-shaped						
headwalls on both ends. Flap gate on the waterside (WS) end. Installed						
by USACE in 1966. [Additional Reference(s): DWR Levee Log, 2005.						
USACE San Joaquin O&M Manual 4, June 1968, (HLM 1.80)].						
FS Date: 9/11/2013

Concrete U-shaped headwall on WS toe.

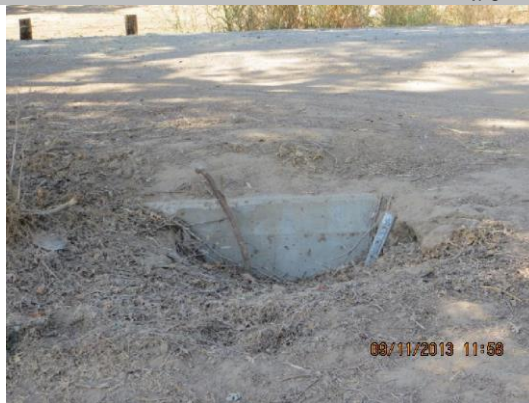
Photo 3 of 3 : UCIP\_SP\_2019\_20109\_34073.jpg

Concrete headwall on LS shoulder.

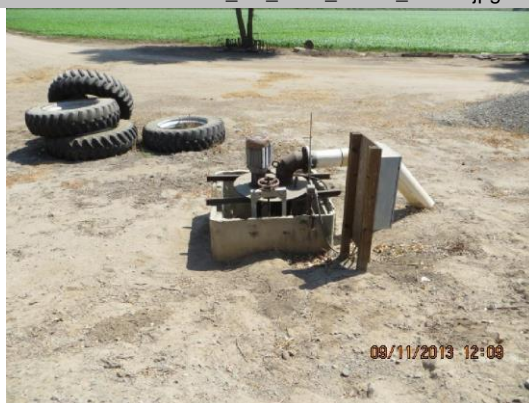
Photo 3 of 3 : UCIP\_SP\_2019\_20110\_34076.jpg

LM Start	2.39	Rating **	A/W	Issue No.	984 (cont)	
LM End	2.39	Issue Type +	Ma	Location *		
Category	Supplemental			GPS Latitude/Longitude		
				Start	End	
Item	DWR UCIP LMA Responsibility			37.688676 °	37.688676 °	
				-121.179622 °	-121.179622 °	
DWR ID	20449					
Comment Code						
Inspector Comment						
FS_ID:20110 DS_ID:20449 EP_NO: N/A Repair Type: No Action Needed Crossing Status: Found UCIP Comments: FIELD_STRUCT_DESC: 24-inch corrugated metal drainage pipe through the levee, 3 feet below the crown. Concrete U-shaped headwall on the waterside (WS) end. Flap gate on the WS end. 5-foot by 5-foot concrete riser with pump on the LS toe. Likely that concrete riser is inlet for drainage pipe. [Additional Reference(s): DWR Levee Log, 2005. USACE San Joaquin O&M Manual 4, June 1968, (HLM 2.41)]. FS Date: 9/11/2013

5'X5' concrete riser with pump on LS toe.

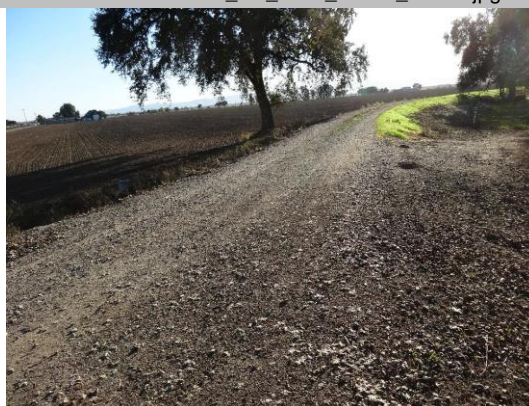
Photo 2 of 3 : UCIP\_SP\_2019\_51340\_76567.jpg

Comment Code						
Inspector Comment						
FS_ID:51340 DS_ID:24669 EP_NO: N/A Repair Type: Non-Urgent Crossing Status: Found UCIP Comments: 11/16/2016 No access to WS due to cattle fence in place. Need to coordinate with property owner to obtain access on WS. Unable to find inlet on LS. Recommend internal inspection of crossing. Crossing has been downgraded from Urgent to Non-Urgent no signs of leaks where present on crown or slopes where pipe should be. (O. Magana - DWR UCIP)09/11/2013 Flapgate partially blocked by soil on WS toe. Good candidate for video inspection. (W. Wylie - DWR UCIP) FIELD_STRUCT_DESC: 24-inch corrugated metal drainage pipe through the levee, at an unknown depth. Flap gate on the waterside (WS) toe. Pipe may originate at a concrete distribution box on the landside (LS) toe. FS Date: 11/16/2016

Overview of levee crown where pipe should cross levee. Limited access on WS due to fence.

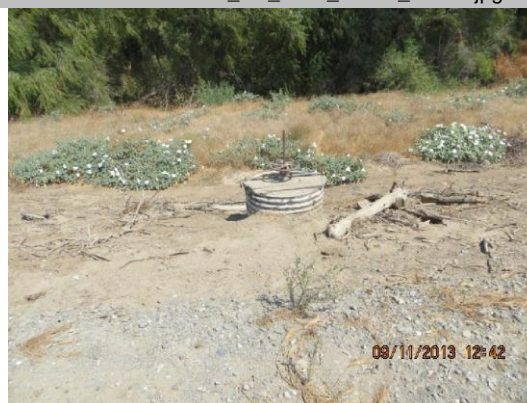
Photo 1 of 3 : UCIP\_SP\_2019\_20449\_34506.jpg

LM Start	3.08	Rating **	M	Issue No.	986
LM End	3.08	Issue Type +	Ma	Location *	
Category	Supplemental			GPS Latitude/Longitude	
				Start	End
Item	DWR UCIP LMA Responsibility			37.688297 °	37.688297 °
				-121.190865 °	-121.190865 °
DWR ID	20451				
Comment Code					
Inspector Comment					
FS_ID:20449 DS_ID:20451 EP_NO: N/A Repair Type: Non-Urgent Crossing Status: Found UCIP Comments: Pipe appears to be abandoned and if so should be done so properly. FIELD_STRUCT_DESC: *ABANDONED* 24-inch corrugated metal drainage pipe through the levee, 14 feet below the crown. Slide gate in a 36-inch corrugated metal pipe (CMP) riser on the waterside (WS) slope. [Additional Reference(s): DWR Levee Log, 2005. USACE San Joaquin O&M Manual 4, June 1968, (HLM 3.11)]. FS Date: 9/11/2013

Slide gate in CMP riser on WS slope.

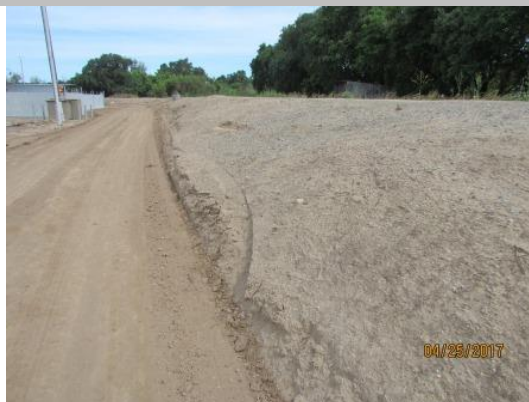
Photo 1 of 1 : SP\_2019\_RD2031\_307\_55\_20190313\_00017.jpg

LM Start	3.17	Rating **	M	Issue No.	55
LM End	3.28	Issue Type +	En	Location *	LS
Category	Earthen Levee			GPS Latitude/Longitude	
				Start	End
Item	Encroachments			37.689368 °	37.690829 °
				-121.191680 °	-121.192511 °
DWR ID	DWR_RD2031_01_f_2013_55				
Comment Code					
AT : Agricultural tilling					
Inspector Comment					
Landside levee toe has about 12 inch vertical cut.

View of the levee toe cut. Looking downstream.

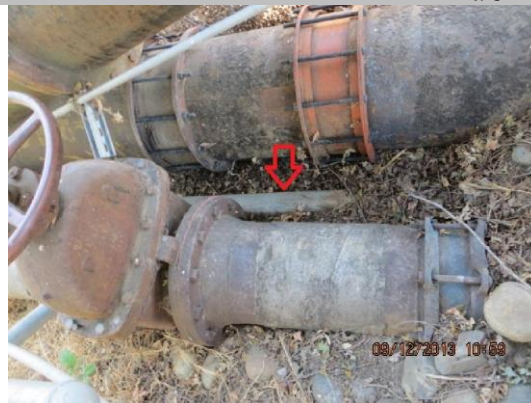
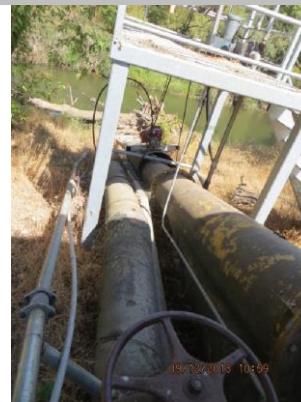
LM Start	3.69	Rating **	M	Issue No.	988
LM End	3.69	Issue Type +	En	Location *	
Category	Supplemental			GPS Latitude/Longitude	
				Start	End
Item	DWR UCIP Field Study			37.689742 °	37.689742 °
				-121.198778 °	-121.198778 °
DWR ID	24672				
Comment Code					
Inspector Comment					
FS_ID:22843 DS_ID:24672 EP_NO: N/A Repair Type: Non-Urgent Crossing Status: Found UCIP Comments: No permit identified for this possible crossing. FIELD_STRUCT_DESC: 4-inch steel irrigation pipe through the levee, at an unknown depth. Pipe visible between larger irrigation pipes below slant pump on the waterside (WS) slope. FS Date: 9/12/2013

Pipe visible between larger irrigation pipes below slant pump on WS slope.

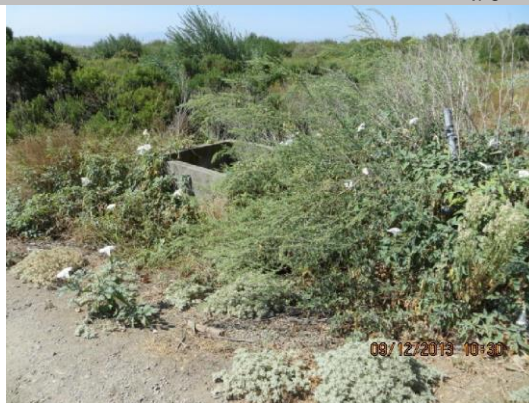
Photo 1 of 3 : UCIP\_SP\_2019\_20667\_34750.jpg

Comment Code						
Inspector Comment						
FS_ID:20667						
DS_ID:20456						
EP_NO: N/A						
Repair Type: Non-Urgent						
Crossing Status: Found						
UCIP Comments: Siphon breaker missing from LS shoulder. Fish screen and pipe end covered in debris that may cause damage to pipe.						
FIELD_STRUCT_DESC: 1 of 2: 20-inch steel irrigation pipe through the levee, 3.9 feet below the crown. Slant pump in pump house mounted on piles on the berm. Siphon breaker in a corrugated metal pipe (CMP) riser on the landside (LS) shoulder. Service pole on the LS slope. 5-foot by 5-foot concrete distribution box on the LS toe with flap gate.						
[Additional Reference(s): DWR Levee Log, 2005. USACE San Joaquin O&M Manual 4, June 1968, (HLM 3.70)].						
FS Date: 9/12/2013

Concrete distribution box on LS slope.

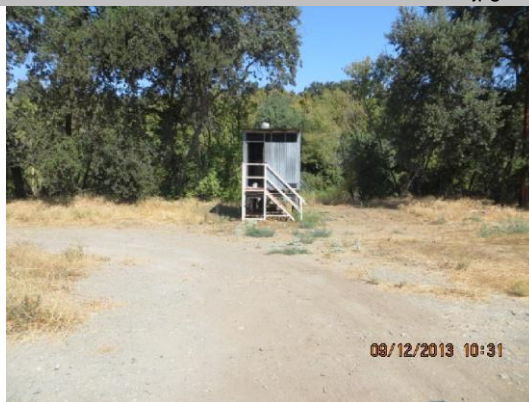
Photo 2 of 3 : UCIP\_SP\_2019\_20667\_34749.jpg

Slant pump in pumphouse on WS berm.

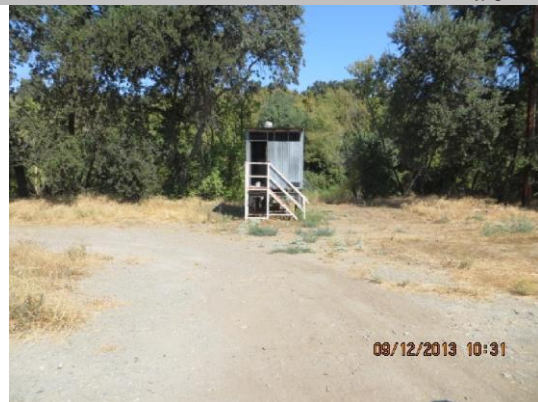
Photo 1 of 3 : UCIP\_SP\_2019\_22845\_39021.jpg

LM Start	3.69	Rating **	M	Issue No.	990
LM End	3.69	Issue Type +	En	Location *	
Category	Supplemental			GPS Latitude/Longitude	
				Start	End
Item	DWR UCIP Field Study			37.689757 °	37.689757 °
				-121.198804 °	-121.198804 °
DWR ID	24671				
Comment Code					
Inspector Comment					
FS_ID:22845 DS_ID:24671 EP_NO: N/A Repair Type: Non-Urgent Crossing Status: Found UCIP Comments: No permit identified for this possible crossing. FIELD_STRUCT_DESC: 2.5-inch galvanized iron irrigation pipe through the levee, at an unknown depth. Submersible pump on the waterside (WS) slope. FS Date: 9/12/2013

Pipe visible on WS of pumphouse.

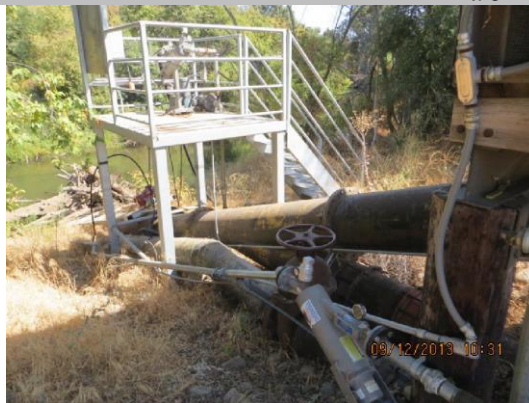
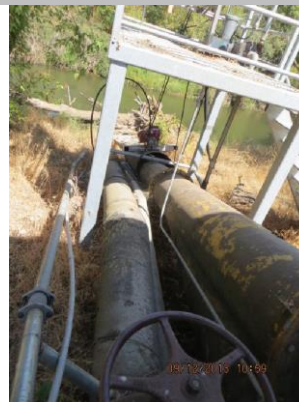
LM Start	3.69	Rating **	M	Issue No.	990 (cont)	
LM End	3.69	Issue Type +	En	Location *		
Category	Supplemental			GPS Latitude/Longitude		
				Start	End	
Item	DWR UCIP Field Study			37.689757 °	37.689757 °	
				-121.198804 °	-121.198804 °	
DWR ID	24671					
Comment Code						
Inspector Comment						
FS_ID:22845 DS_ID:24671 EP_NO: N/A Repair Type: Non-Urgent Crossing Status: Found UCIP Comments: No permit identified for this possible crossing. FIELD_STRUCT_DESC: 2.5-inch galvanized iron irrigation pipe through the levee, at an unknown depth. Submersible pump on the waterside (WS) slope. FS Date: 9/12/2013

Pipe and appurtenances visible on downstream side of and next to larger irrigation pipe.

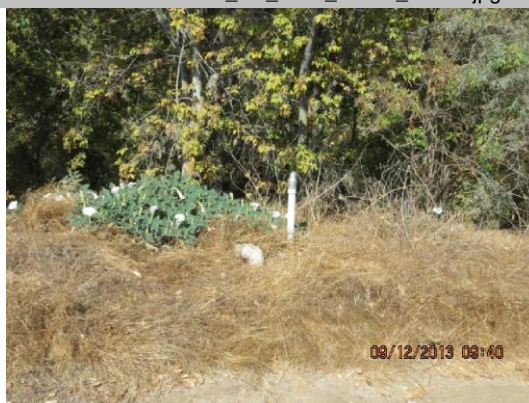
LM Start	4.40	Rating **	M	Issue No.	991
LM End	4.40	Issue Type +	En	Location *	
Category	Supplemental			GPS Latitude/Longitude	
				Start	End
Item	DWR UCIP Field Study			37.686500 °	37.686500 °
				-121.207900 °	-121.207900 °
DWR ID	24673				
Comment Code					
Inspector Comment					
FS_ID:22846 DS_ID:24673 EP_NO: N/A Repair Type: Non-Urgent Crossing Status: Found UCIP Comments: No permit identified for this possible crossing. FIELD_STRUCT_DESC: 4-inch galvanized iron irrigation pipe visible on the waterside (WS) shoulder. Pipe may go through the levee, at an unknown depth. Vent on the WS shoulder. FS Date: 9/12/2013

Pipe and vent visible on WS shoulder.

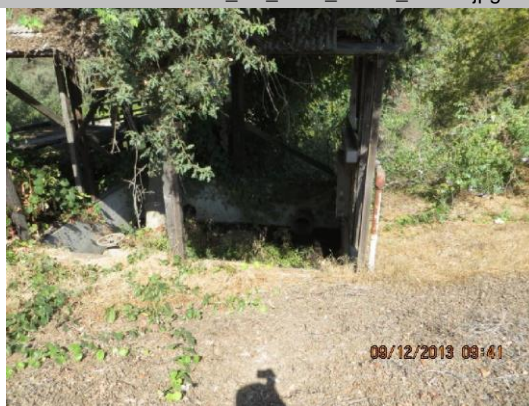
Photo 1 of 3 : UCIP\_SP\_2019\_20683\_34782.jpg

LM Start	4.41	Rating **	A/W	Issue No.	992
LM End	4.41	Issue Type +	Ma	Location *	
Category	Supplemental			GPS Latitude/Longitude	
				Start	End
Item	DWR UCIP LMA Responsibility			37.686290 °	37.686290 °
				-121.208000 °	-121.208000 °
DWR ID	20458				
Comment Code					
Inspector Comment					
FS_ID:20683 DS_ID:20458 EP_NO: N/A Repair Type: No Action Needed Crossing Status: Found UCIP Comments: FIELD_STRUCT_DESC: *ABANDONED* 1 of 2: 14-inch concrete encased steel drainage pipe through the levee, 7.5 feet below the crown. Plate welded on the waterside (WS) end. 6-foot by 12-foot concrete distribution box on the landside (LS) toe. [Additional Reference(s): DWR Levee Log, 2005. USACE San Joaquin O&M Manual 4, June 1968, (HLM 4.46)]. FS Date: 9/12/2013

Pipe visible inside pumphouse on WS slope.

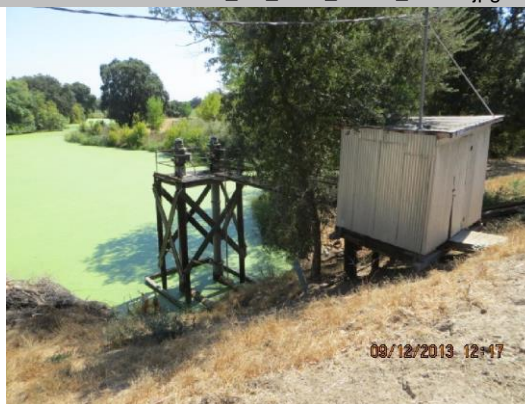
Photo 1 of 3 : UCIP\_SP\_2019\_20703\_34822.jpg

LM Start	<b>0.22</b>	Rating **	A/W	Issue No.	<b>967</b>
LM End	<b>0.22</b>	Issue Type +	Ma	Location *	
Category	Supplemental		GPS Latitude/Longitude		
			Start	End	
Item	DWR UCIP LMA Responsibility		37.658888 °	37.658888 °	
			-121.234274 °	-121.234274 °	
DWR ID	20482				
Comment Code					
Inspector Comment					
FS_ID:20703					
DS_ID:20482					
EP_NO: N/A					
Repair Type: No Action Needed					
Crossing Status: Found					
UCIP Comments:					
FIELD_STRUCT_DESC: 1 of 2: 24-inch steel drainage pipe through the levee, 3.6 feet below the crown. Concrete U-shaped headwall on the waterside (WS) end. Flap gate on the WS end. Pump on pile structure on the landside (LS). [Additional Reference(s): DWR Levee Log, 2005. USACE San Joaquin O&M Manual 4, June 1968, (HLM 0.24)].					
FS Date: 9/12/2013

Pump on platform at LS toe.

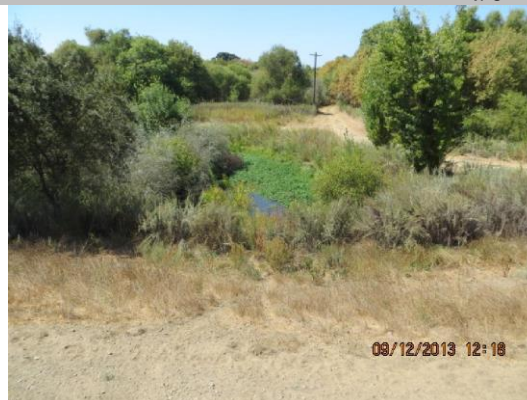
Photo 2 of 3 : UCIP\_SP\_2019\_20703\_34821.jpg

LM Start	0.22	Rating **	A/W	Issue No.	967 (cont)	
LM End	0.22	Issue Type +	Ma	Location *		
Category	Supplemental			GPS Latitude/Longitude		
				Start	End	
Item	DWR UCIP LMA Responsibility			37.658888 °	37.658888 °	
				-121.234274 °	-121.234274 °	
DWR ID	20482					
Comment Code						
Inspector Comment						
FS_ID:20703						
DS_ID:20482						
EP_NO: N/A						
Repair Type: No Action Needed						
Crossing Status: Found						
UCIP Comments:						
FIELD_STRUCT_DESC: 1 of 2: 24-inch steel drainage pipe through the levee, 3.6 feet below the crown. Concrete U-shaped headwall on the waterside (WS) end. Flap gate on the WS end. Pump on pile structure on the landside (LS). [Additional Reference(s): DWR Levee Log, 2005. USACE San Joaquin O&M Manual 4, June 1968, (HLM 0.24)].						
FS Date: 9/12/2013

Pond at outlet on WS toe.

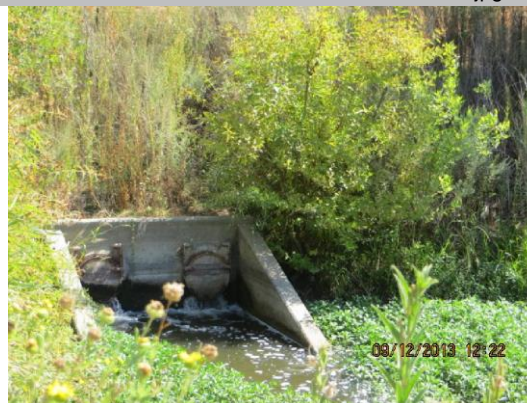
Photo 3 of 3 : UCIP\_SP\_2019\_20703\_34820.jpg

Concrete U-shaped headwall with flapgate on WS toe.

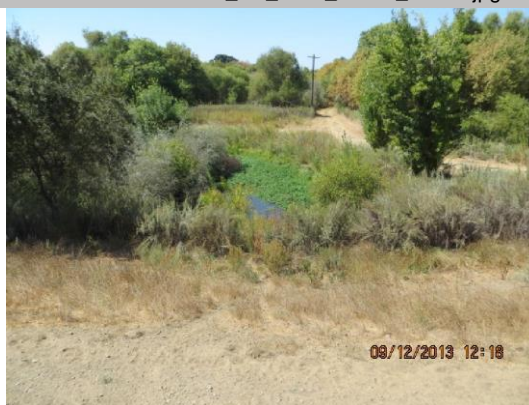
Photo 2 of 3 : UCIP\_SP\_2019\_20704\_34825.jpg

LM Start	0.22	Rating **	A/W	Issue No.	968
LM End	0.22	Issue Type +	Ma	Location *	
Category	Supplemental			GPS Latitude/Longitude	
				Start	End
Item	DWR UCIP LMA Responsibility			37.658875 °	37.658875 °
				-121.234280 °	-121.234280 °
DWR ID	20508				
Comment Code					
Inspector Comment					
FS_ID:20704 DS_ID:20508 EP_NO: N/A Repair Type: No Action Needed Crossing Status: Found UCIP Comments: FIELD_STRUCT_DESC: 2 of 2: 24-inch steel drainage pipe through the levee, 3.6 feet below the crown. Concrete U-shaped headwall on the waterside (WS) end, and a concrete headwall at the landside (LS) toe. Flap gate on the WS end. Pump on pile structure on the LS. [Additional Reference(s): DWR Levee Log, 2005. USACE San Joaquin O&M Manual 4, June 1968, (HLM 0.24)]. FS Date: 9/12/2013

Pond at outlet on WS toe.

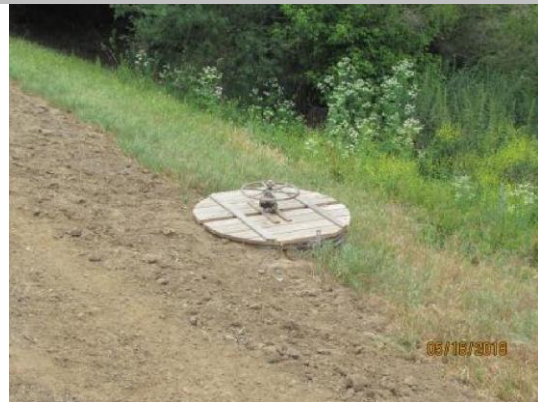
Photo 1 of 3 : UCIP\_SP\_2019\_53836\_77560.jpg

LM Start	0.24	Rating **	M	Issue No.	969	
LM End	0.24	Issue Type +	Ma	Location *		
Category	Supplemental			GPS Latitude/Longitude		
				Start		End
Item	DWR UCIP LMA Responsibility			37.658595 °		37.658595 °
				-121.234410 °		-121.234410 °
DWR ID	20484					
Comment Code						
Inspector Comment						
FS_ID:53836 DS_ID:20484 EP_NO: N/A Repair Type: Non-Urgent Crossing Status: Found UCIP Comments: 05/17/2018 LMA installed lid on top of riser (D. Sanoski - DWR UCIP). FIELD_STRUCT_DESC: 48-inch corrugated metal drainage pipe through the levee, 22.8 feet below the crown. Slide gate in a 5-foot-diameter corrugated metal pipe (CMP) riser on the waterside (WS) slope. Concrete U-shaped headwalls on both ends. Flap gate on the WS end. [Additional Reference(s): DWR Levee Log, 2005. USACE San Joaquin O&M Manual 4, June 1968, (HLM 0.26)]. FS Date: 5/17/2018

5/17/2018- Newly installed lid.

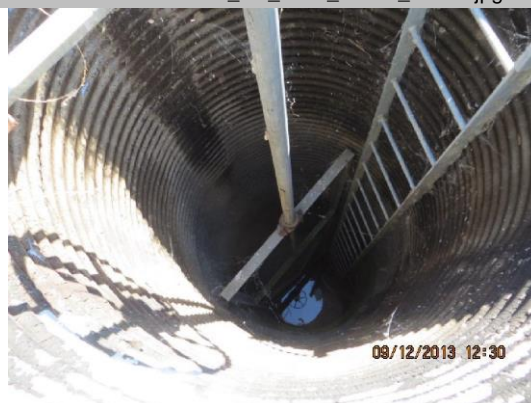
Photo 2 of 3 : UCIP\_SP\_2019\_53836\_34834.jpg

Slide gate in CMP riser on WS slope.

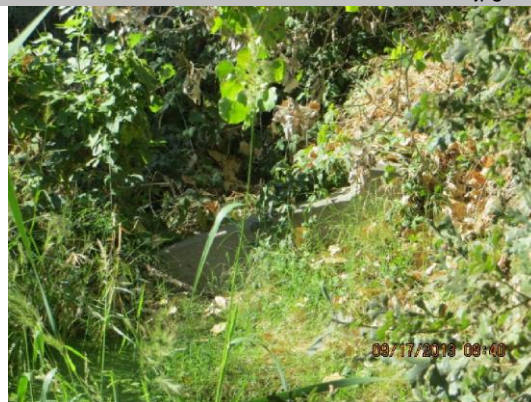
Photo 3 of 3 : UCIP\_SP\_2019\_53836\_34833.jpg

Concrete headwall on LS toe at edge of pond.

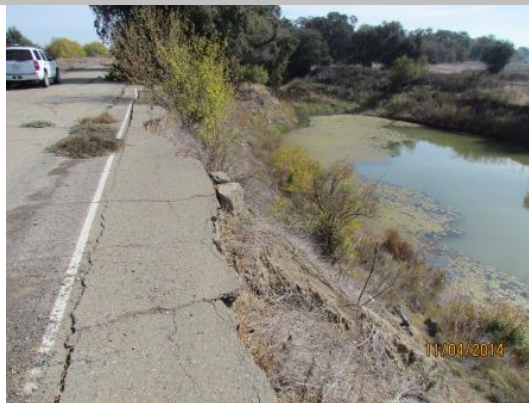
Photo 1 of 1 : SP\_2019\_RD2031\_308\_26\_20190313\_00007.jpg

LM Start	2.27	Rating **	U	Issue No.	26
LM End	2.28	Issue Type +	Ob	Location *	WS
Category	Earthen Levee			GPS Latitude/Longitude	
				Start	End
Item	Erosion / Bank Caving			37.640371 °	37.640340 °
				-121.219254 °	-121.218974 °
DWR ID	DWR_RD2031_02_f_2014_26				
Comment Code					
E2 : Schedule repair of erosion site prior to the next inspection.					
Inspector Comment

View of the caving bank on the waterside facing upstream.

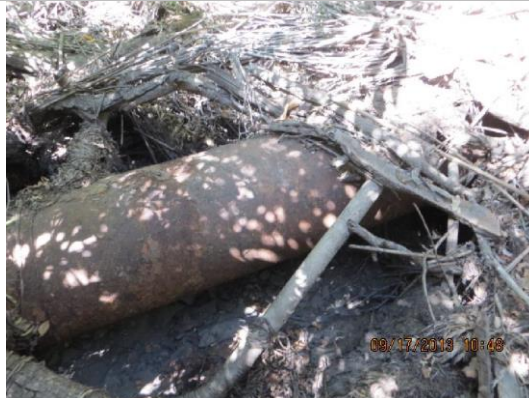
Photo 1 of 3 : UCIP\_SP\_2019\_20713\_34838.jpg

Comment Code					
Inspector Comment					
FS_ID:20713 DS_ID:20490 EP_NO: 11758 Repair Type: Non-Urgent Crossing Status: Found UCIP Comments: Pipe rusted through and failing at WS toe. Good indicator of internal condition of pipe. Good candidate for video inspection. FIELD_STRUCT_DESC: 24-inch corrugated metal gravity drainage pipe through the levee, 17 feet below the crown. 20-inch steel pipe and 1.25-inch galvanized conduit sleeved through the 24-inch pipe. Annular space pressure grouted. Slide gate in a 48-inch corrugated metal pipe (CMP) riser on the landside (LS) slope. 36-inch concrete standpipe at the LS toe with pump on a 48-inch steel standpipe. (20-inch and 1.5-inch pipes installed under Permit No. 11758, 1976 - Faith Ranch). [Additional Reference(s): DWR Levee Log, 2005. USACE San Joaquin O&M Manual 4, June 1968, (HLM 2.75)]. FS Date: 9/17/2013

Pipe visible on LS toe.

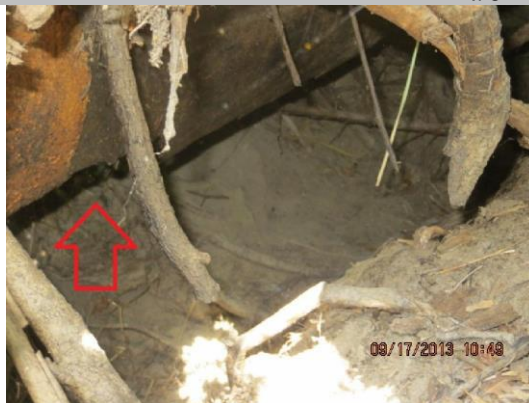
Photo 2 of 3 : UCIP\_SP\_2019\_20713\_34837.jpg

Comment Code						
Inspector Comment						
FS_ID:20713 DS_ID:20490 EP_NO: 11758 Repair Type: Non-Urgent Crossing Status: Found UCIP Comments: Pipe rusted through and failing at WS toe. Good indicator of internal condition of pipe. Good candidate for video inspection. FIELD_STRUCT_DESC: 24-inch corrugated metal gravity drainage pipe through the levee, 17 feet below the crown. 20-inch steel pipe and 1.25-inch galvanized conduit sleeved through the 24-inch pipe. Annular space pressure grouted. Slide gate in a 48-inch corrugated metal pipe (CMP) riser on the landside (LS) slope. 36-inch concrete standpipe at the LS toe with pump on a 48-inch steel standpipe. (20-inch and 1.5-inch pipes installed under Permit No. 11758, 1976 - Faith Ranch). [Additional Reference(s): DWR Levee Log, 2005. USACE San Joaquin O&M Manual 4, June 1968, (HLM 2.75)]. FS Date: 9/17/2013

Flow line of pipe completely rusted through at LS toe.

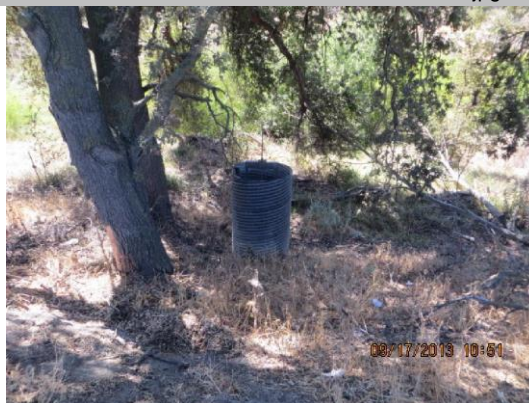
Photo 3 of 3 : UCIP\_SP\_2019\_20713\_34836.jpg

Slide gate in 48-inch CMP riser on WS slope.

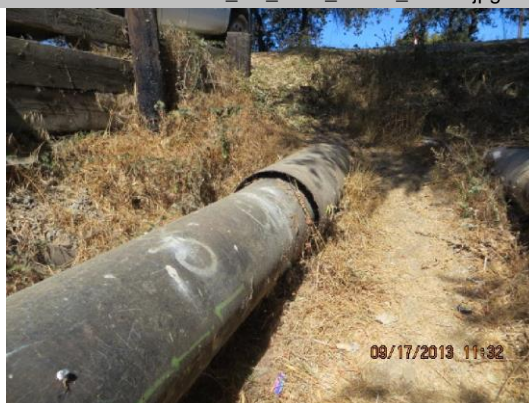
Photo 1 of 3 : UCIP\_SP\_2019\_20719\_34860.jpg

24-inch with 20-inch sleeved through it.

Comment Code					
Inspector Comment					
FS_ID:20719					
DS_ID:20492					
EP_NO: N/A					
Repair Type: Non-Urgent					
Crossing Status: Found					
UCIP Comments: Annular space between 20-inch and 24-inch pipe not grouted.					
FIELD_STRUCT_DESC: 24-inch steel irrigation pipe through the levee, 8 feet below the crown. 20-inch steel pipe sleeved through the 24-inch pipe. Pump on pile structure in river. 4-foot by 11-foot concrete distribution box on the landside (LS) toe. 2-inch electrical conduit at the same location. [Additional Reference(s): DWR Levee Log, 2005. USACE San Joaquin O&M Manual 4, June 1968, (HLM 3.24)].					
FS Date: 9/17/2013

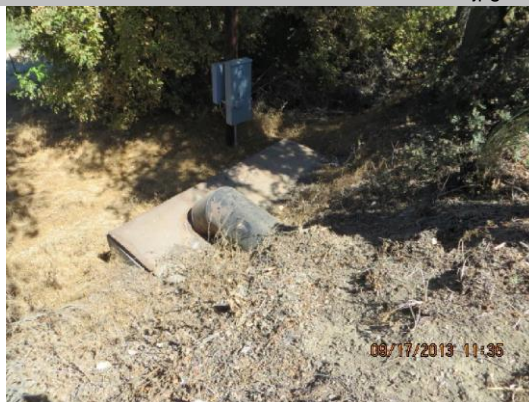
Photo 2 of 3 : UCIP\_SP\_2019\_20719\_34859.jpg

Concrete distribution box on LS slope.

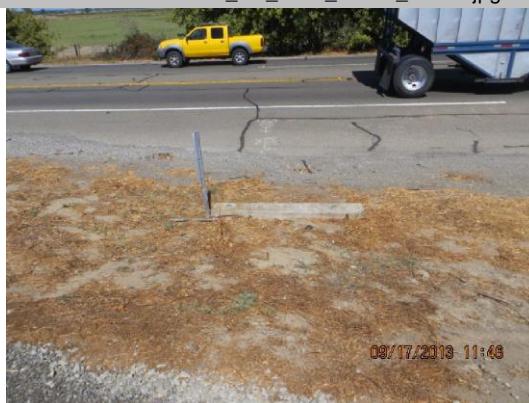
Photo 2 of 3 : UCIP\_SP\_2019\_20723\_34881.jpg

Concrete headwall on LS toe.

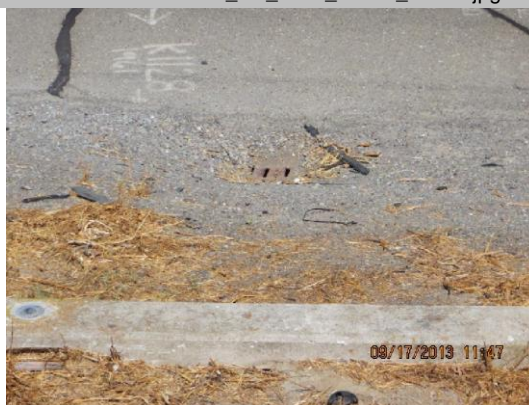
Photo 3 of 3 : UCIP\_SP\_2019\_20723\_34880.jpg

Drop inlet on LS toe.

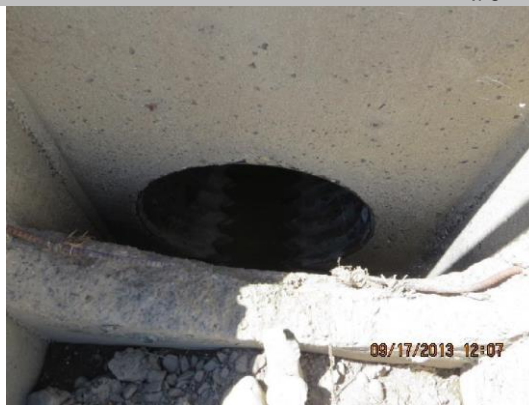
Photo 2 of 3 : UCIP\_SP\_2019\_20728\_34894.jpg

Concrete headwall on LS toe.

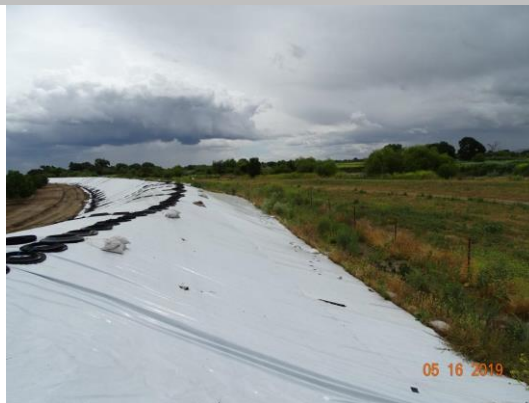
Photo 2 of 2 : SP\_2019\_RD2031\_308\_16\_20190520\_00044.jpg

LM Start	4.22	Rating **	U	Issue No.	16 (cont)	
LM End	4.51	Issue Type +	En	Location *	CR	
Category	Earthen Levee			GPS Latitude/Longitude		
				Start	End	
Item	Encroachments			37.632503 °	37.630917 °	
				-121.190603 °	-121.185895 °	
DWR ID	DWR_RD2031_02_s_2019_16					
Comment Code						
MA : Material						
Inspector Comment						
Visqueen was installed in 2017 on the waterside, the crown, and the landside of the levee. Material does not allow for an evaluation of levee. Recommend removing material prior to fall inspection. (Spring 2019)

View of visqueen on crown and waterside slope installed in 2017.  
(Spring 2019)

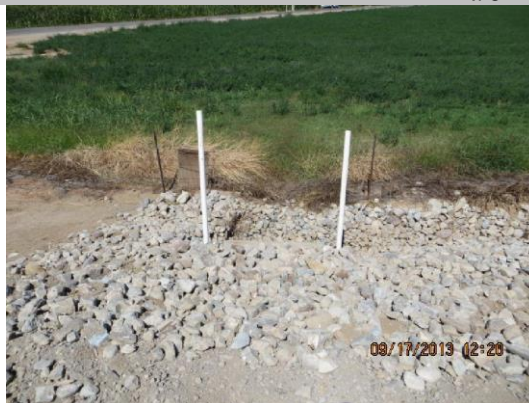
Photo 1 of 3 : UCIP\_SP\_2019\_22872\_39036.jpg

LM Start	4.70	Rating **	M	Issue No.	976
LM End	4.70	Issue Type +	En	Location *	
Category	Supplemental			GPS Latitude/Longitude	
				Start	End
Item	DWR UCIP Field Study			37.630815 °	37.630815 °
				-121.182416 °	-121.182416 °
DWR ID	24676				
Comment Code					
Inspector Comment					
FS_ID:22872 DS_ID:24676 EP_NO: N/A Repair Type: Non-Urgent Crossing Status: Found UCIP Comments: No permit identified for this crossing. FIELD_STRUCT_DESC: 16-inch polyvinyl chloride (PVC) irrigation pipe through the levee, 6 feet below the crown. Headwall on the landside (LS) toe. FS Date: 9/17/2013

Concrete headwall at outlet on LS toe.

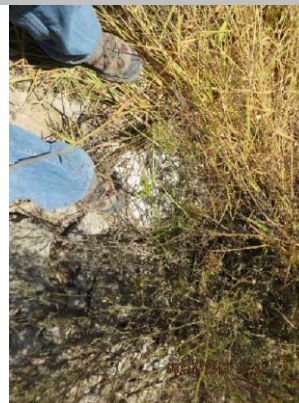
Photo 3 of 3 : UCIP\_SP\_2019\_22872\_39034.jpg

LM Start	4.70	Rating **	M	Issue No.	976 (cont)	
LM End	4.70	Issue Type +	En	Location *		
Category	Supplemental			GPS Latitude/Longitude		
				Start	End	
Item	DWR UCIP Field Study			37.630815 °	37.630815 °	
				-121.182416 °	-121.182416 °	
DWR ID	24676					
Comment Code						
Inspector Comment						
FS_ID:22872 DS_ID:24676 EP_NO: N/A Repair Type: Non-Urgent Crossing Status: Found UCIP Comments: No permit identified for this crossing. FIELD_STRUCT_DESC: 16-inch polyvinyl chloride (PVC) irrigation pipe through the levee, 6 feet below the crown. Headwall on the landside (LS) toe. FS Date: 9/17/2013

PVC pipe partially visible on WS toe.

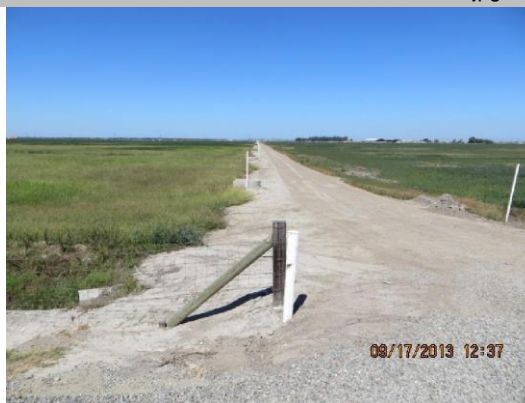
Photo 1 of 2 : UCIP\_SP\_2019\_22873\_39038.jpg

LM Start	5.63	Rating **	M	Issue No.	977	
LM End	5.63	Issue Type +	En	Location *		
Category	Supplemental			GPS Latitude/Longitude		
				Start	End	
Item	DWR UCIP Field Study			37.630779 °	37.630779 °	
				-121.165402 °	-121.165402 °	
DWR ID	24677					
Comment Code						
Inspector Comment						
FS_ID:22873 DS_ID:24677 EP_NO: N/A Repair Type: Non-Urgent Crossing Status: Found UCIP Comments: No permit identified for this crossing. FIELD_STRUCT_DESC: 24-inch polyvinyl chloride (PVC) irrigation pipe through the levee, 5 feet below the crown. Slide gate at the waterside (WS) shoulder. 6-inch steel riser on the WS shoulder. FS Date: 9/17/2013

Concrete turnouts visible off LS toe along road.
